**Development of Guidelines for Reduction of  
Temperature Differential Damage (TDD) for Hot Mix  
Asphalt Pavement Projects in Connecticut  
Final Report**

Report No.  
2222-F-04-9

Connecticut Department of Transportation  
Bureau of Engineering and Highway Operations  
Research and Materials

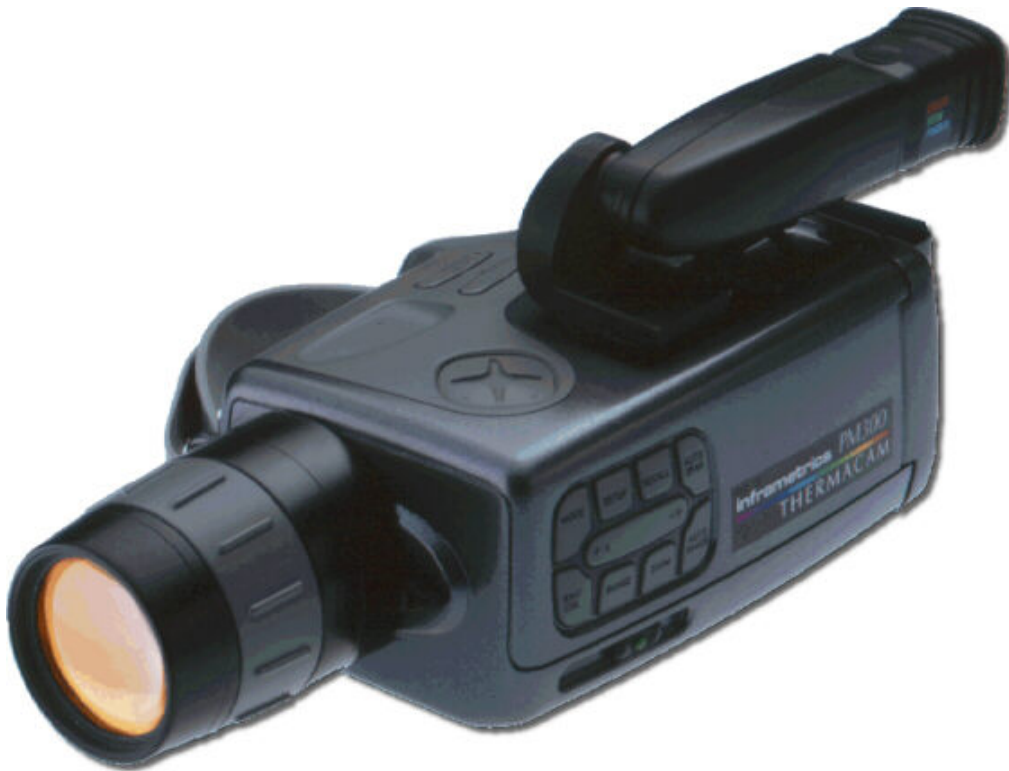
Photo 1. Inframetrics ThermoCAM PM380.

A ThermoCAM PM380 infrared camera (see Photos #1 and #2) was rented for one (1) month from Inframetrics, Inc, the camera's inventor and manufacturer. The ThermoCAM provided a 256 x 256 pixel image, temperature measurements from -10 to 450°C, and an accuracy of +/- 2°C. It operated on a commercially available camcorder battery. Precision 12-bit measurement data were stored instantly in the field as TIFF digital files on a removable FLASH PCMCIA memory card. Inframetrics TherMonitor95 software was used in the laboratory for post-image processing and report generation.

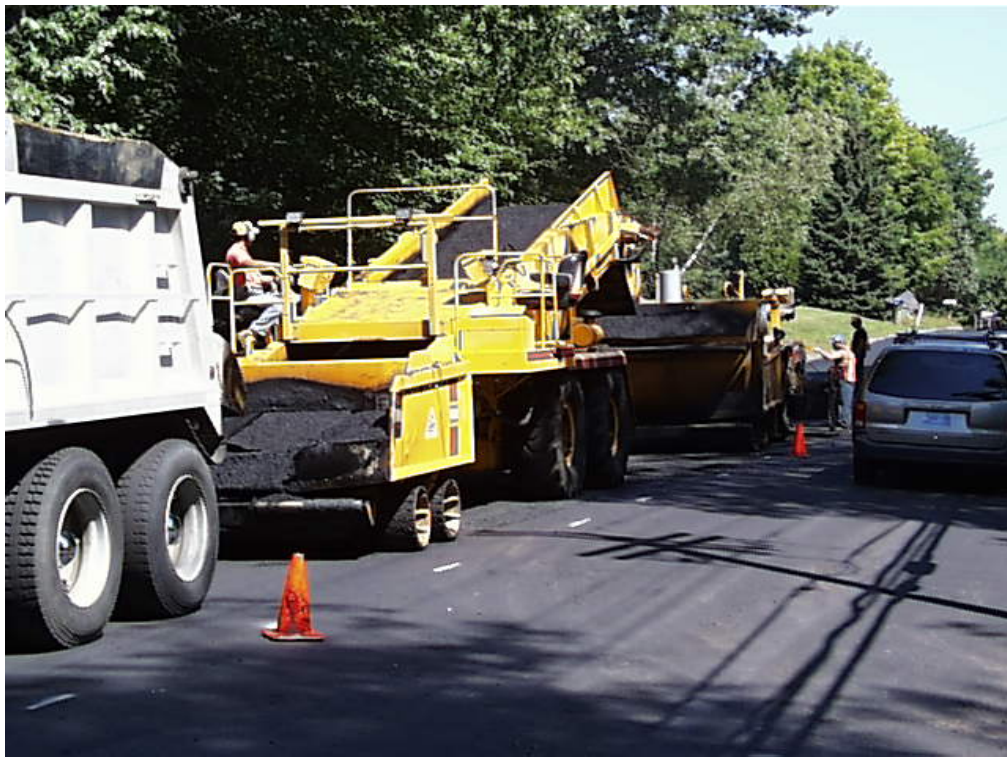
Photo 11. Blaw-Knox MC-30 Material Transfer Vehicle.

For the Route I-91 Rocky Hill project, a Blaw-Knox MC-30 material transfer vehicle (see Photo #11) was employed with a Blaw-Knox PF-180H paver. Additionally, a remixing insert was placed inside the paver's hopper. Infrared video was recorded on October 6, 1998. It was a night project and the ambient temperature was approximately 7 °C (45°F). The haul time to the project was approximately 15 minutes.

The MC-30 material transfer vehicle in combination with the remixing insert did appear to reduce the occurrence of thermal segregation in the 50-mm (2-inch) DOT Class 1 surface layer, but did not completely eliminate the problem (see Photo #12). An occasional cold spot did show in the pavement during construction. It was observed that the freshly laid pavement cooled quickly during rolling

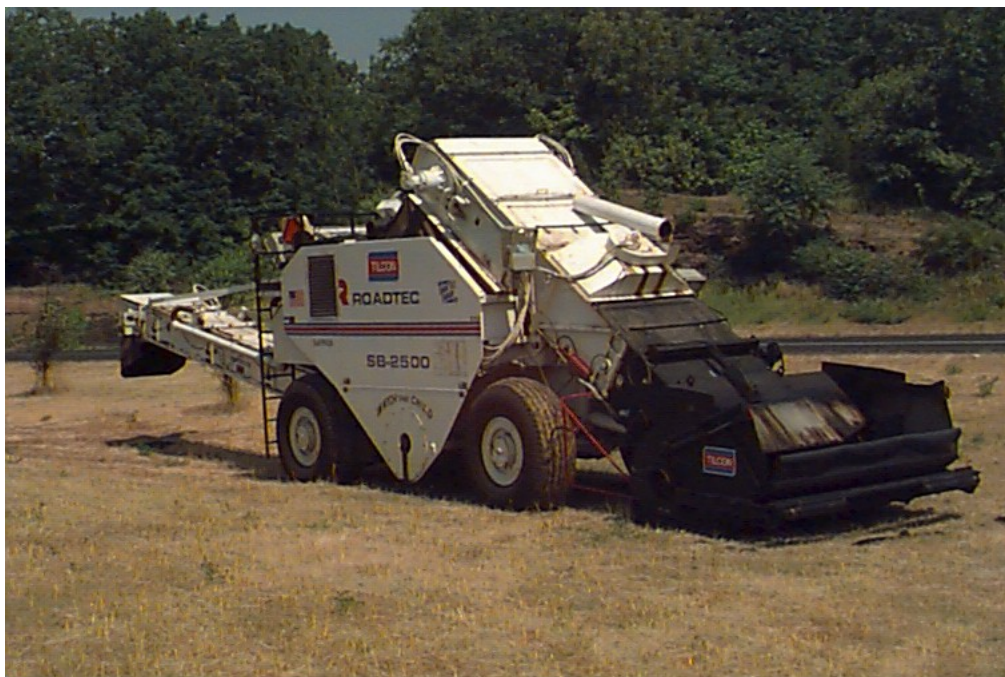
Photo 13. Roadtec Shuttle Buggy Material Transfer Vehicle.

remixing in the Shuttle Buggy (see Photo #14). It should be noted, however, that some temperature differentials did appear in the mat at the beginning of paving operations, when the equipment was cold. Also, it should be noted that the pavement cooled more quickly at night than had typically been observed for daytime construction. Remixing, obviously, has no affect on the rate at which a pavement cools after being placed.

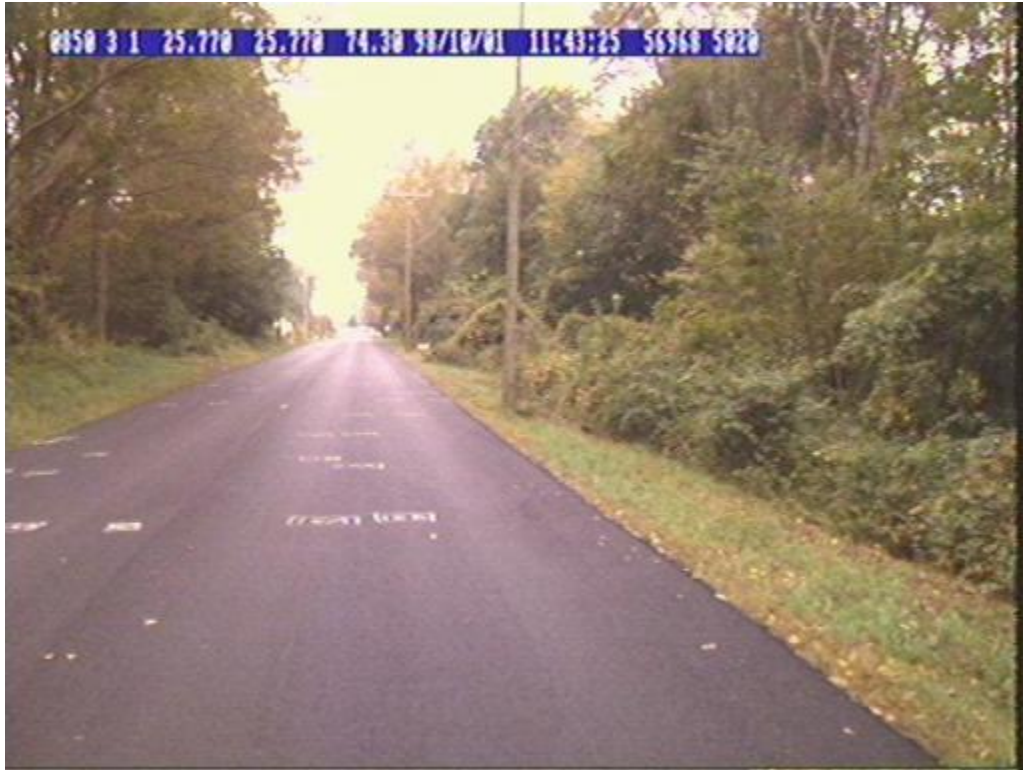
Photo 18 - 1998 Photo of Sites 1 & 2, Route 85 SB & NB in Colchester

relationships between areas of pavement distress and cold spot/areas observed with the infrared camera were not evident during the survey.
